The Clinical Risk of Vertebral Artery Injury From Cervical Pedicle Screws Inserted in Degenerative Vertebrae

SPINE Volume 30, Number 24, pp 2800–2805
©2005, Lippincott Williams & Wilkins, Inc.

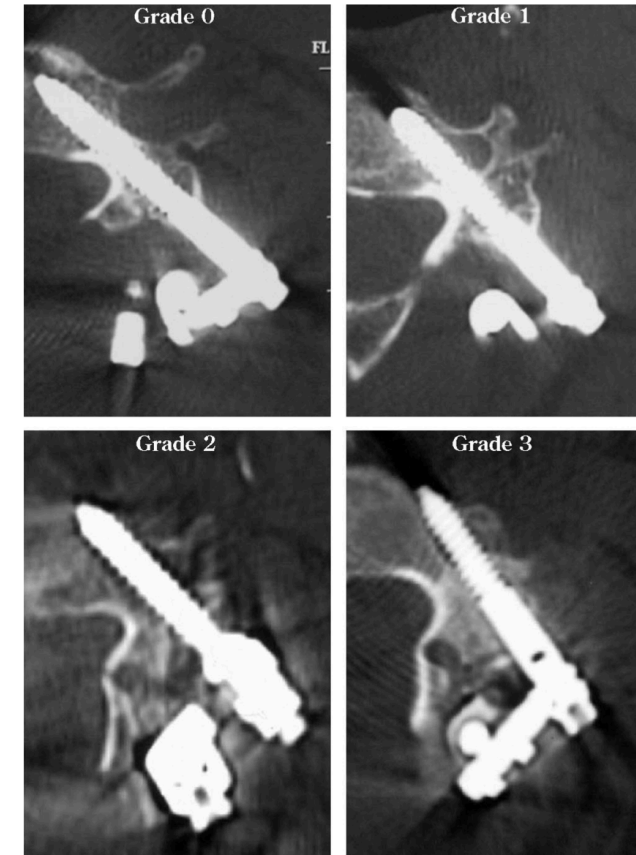
After surgery, the positions of the pedicle screws were evaluated using conventional computerized tomography (CT) by the first author (M.N.), who was also a main member of the operation team. An axial image, including the whole length of each screw, was obtained, and the medial and lateral deviation of the screw was classified into 4 grades. Grade 0, no deviation; the screw was contained in the pedicle. Grade 1, deviation less than 2 mm (i.e., less than half of the screw diameter). Grade 2, deviation more than 2 mm and less than 4 mm. Grade 3, deviation more than 4 mm (i.e., complete deviation) (Figure 1). It
